**LWG ENVIRONMENTAL AUDIT
SUMMARY REPORT
Protocol Issue 5.2.3**

**CPL Group Public Co Ltd
700 Moo 6, Sukhumvit Road
Tambol Bangpoo Mai
Ampur Muang, Samutprakan
10280 Thailand**

February 2012

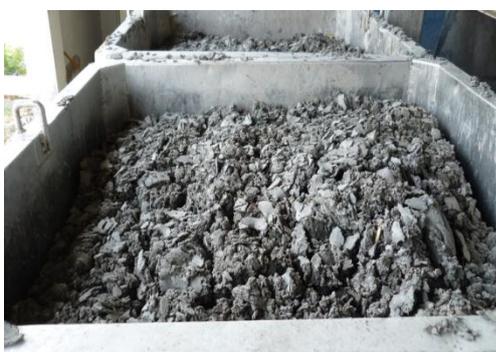
approximately one month before. The photo shows one area where the sludge was laid on the ground. This is not the whole quantity but is representative of the scale of sludge generation: very small for a plant processing 6000 tons of water per day.

The claim was made that the sludge may be disposed of on the land operated by the Tanners Association. The photo above demonstrates what is meant by on the land, the foreground shows recent deposits, the background (greenish tinge) sludge seen on the first visit. It was not totally clear whether the sludge could be legally disposed on the Tanners Association site or not; there was no evidence for a permit to allow this. It appears that some sludge may have been taken away and for this sludge, that had been disposed off site (ie away from land “governed” or controlled by The Tanners Association), there were no disposal notes.

“This waste water plant is not compliant on the basis that the quantity of sludge produced is low, there is no evidence for sludge disposal from the site and it is unclear if the disposal on this land is permitted or not”.

1. *CPL (through the Tanners Association) need to demonstrate that the landfill option on the Tanners Association land is legal.*
2. *Keep data on the quantity of sludge made, in order to demonstrate that the plant is cleaning the water effectively;*
3. *What happens to this sludge? - show what happens with the tonnage, photos etc;*
4. *If the sludge is disposed “off site” (off site means away from the Tanners Assoc land) – again keep records and be able to show this is legal. Disposal notes should show that the sludge is correctly coded: 04 01 07??;*
5. *Chromium cake or chromium sludge disposal should also be of the correct order of magnitude. The current quantity appears too low. Also, in section 15 Q10, CPL will need to find a solution to the question relating to the amount of chromium recycled.*

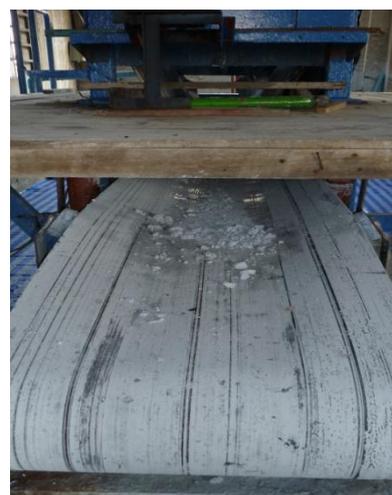
When the waste water treatment plant was visited the final discharge water was not flowing, the sludge in the collection bins below the dewatering devices was dry (indicating there had been no sludge prepared for some time) and the chromium recovery plant appeared to be not working. The

photo on the left shows the sludge collection bins on the first day of the audit. The sludge in the bin was dry. The photo on the right shows the chrome recovery system on the same day, there is no visible production and the filter press appeared not to have been used for some time. Note the pale nature of the recovered chromium cake on the belt, clearly dry. The observations and detail relating to the chromium recovery are set out in the audit responses – section 15 – Box 4.
